New Roofing Concepts in the Military Construction Process

TECHNICAL REPORT M-297
November 1981

EVALUATION OF SPRAYED POLYURETHANE FOAM ROOFING
AND PROTECTIVE COATINGS

by
Myer J. Rosenfield

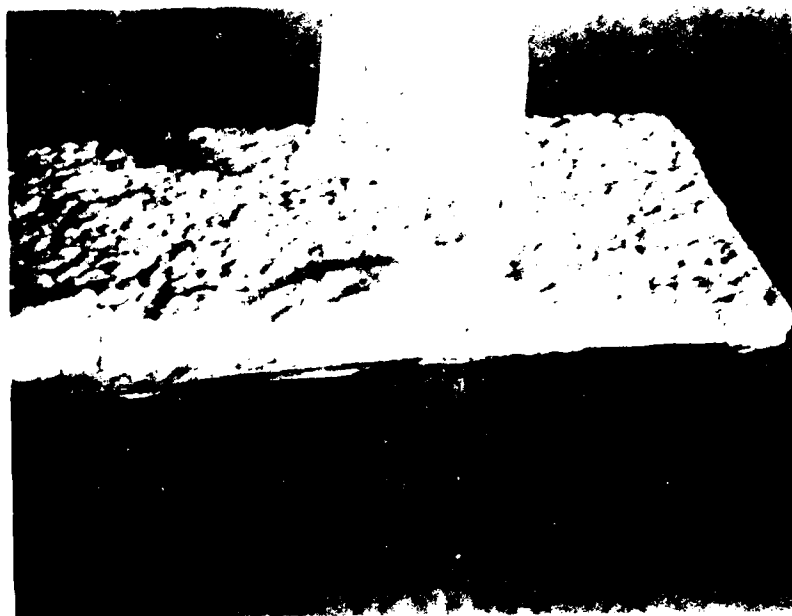
When water or moisture reacts with the isocyanate component, a by-product of the reaction is the formation of CO₂ (carbon dioxide) gas. This gassing causes the foam surface to exhibit high porosity where the reaction occurs. The severity of the condition described varies with the amount of moisture, but porosity does provide a way to visually check whether moisture was present when the foam was sprayed. Surface effects of foaming on a wet surface are shown in Figure 12.

Figure 12. Long-term corrosion product.
